MASSACHUSETTS COASTAL BASIN  
SCITUATE, MASSACHUSETTS

FIRST HERRING BROOK RESERVOIR DAM  
MA 00478

PHASE I INSPECTION REPORT  
NATIONAL DAM INSPECTION PROGRAM

JULY 1981

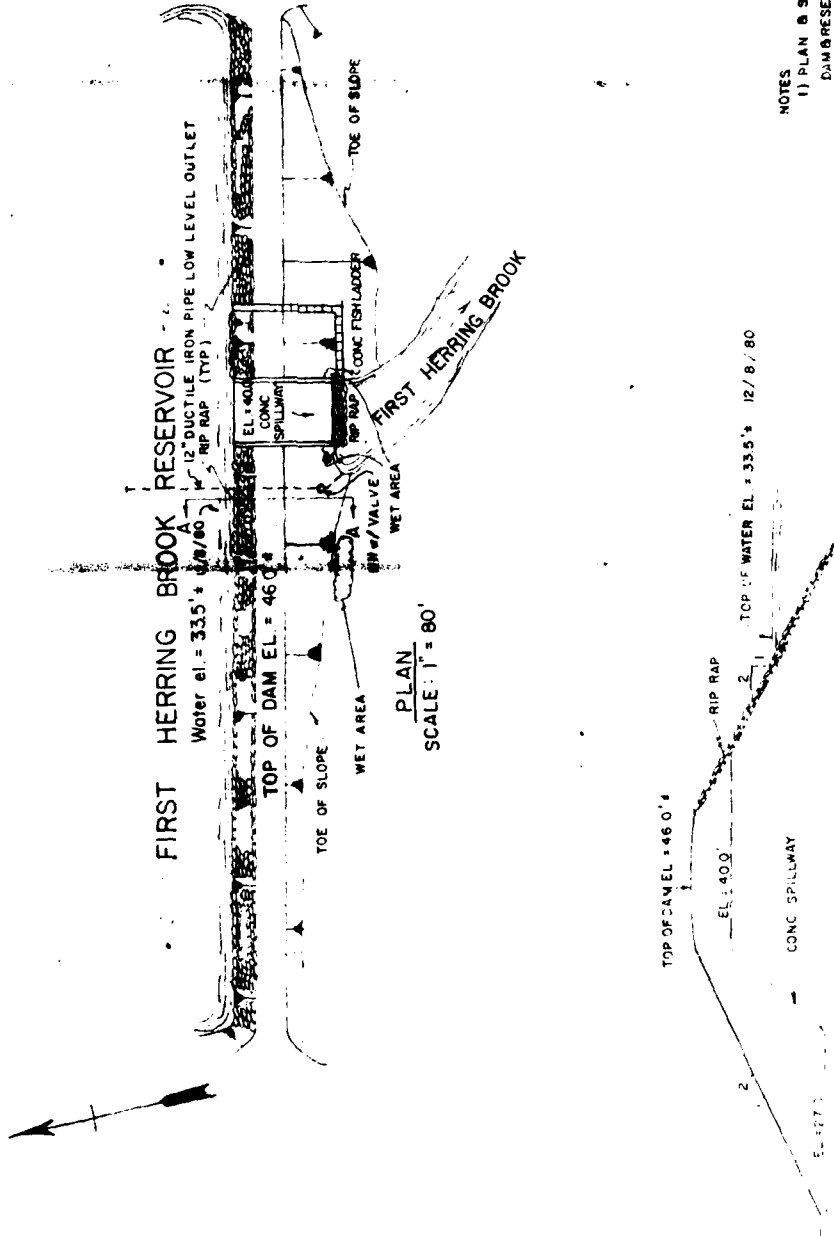
FIGURE 2

The downstream slope is covered with grass, weeds and small brush near the spillway wingwalls. There is one area (shown on Figure 2 page B-1), about 80 feet by 25 feet in size, which is wet and soft but with no visible discharge of seepage water. Several animal burrows up to 12 in. in diameter and 8 in. deep were observed near the toe of the dam approximately 100 feet west of the right spillway training wall.

The soft, wet area adjacent to the downstream toe suggests that the line of seepage through the dam may exit at or near the toe of the slope, a condition which could lead to a piping failure of the embankment if the embankment soils or foundation soils are susceptible to piping. No observation wells or piezometers, which provide a measurement of the phreatic surface in the dam, were

3. Investigate the cause of the soft, wet area at the downstream toe of the slope, design remedial measures and oversee construction of the remedial measures.
